REHABILITATION OF THE HISTORIC BRIDGE OF LIONS

BY ALAN KLEVENS, P.E.

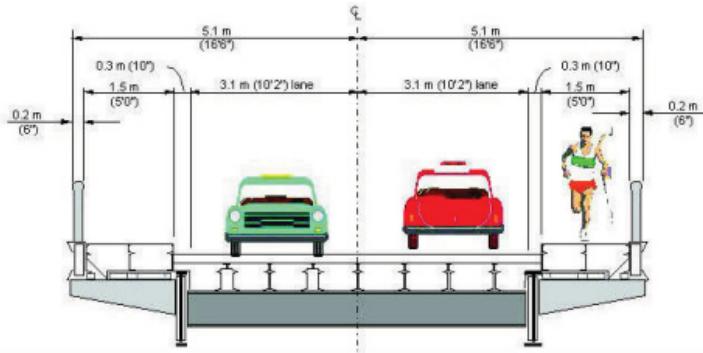
The existing bridge deck is 22'-0" from curb to curb. There are two 5'-0" sidewalks which run the full length of the bridge. The cross section is substandard because of the narrow lane widths and the lack of protection for pedestrians and bicyclists. See Figure 2. Additionally, the railing height and configuration do not meet the AASHTO requirements for pedestrian or bicycle railings.

Figure 2: Existing bascule span cross section.

The scope of the rehabilitation included increasing the roadway and shoulder widths on the approach spans to 25', including two 11' travel lanes, two 1'-6" shoulders, and separation of the sidewalks from the roadway using two 1'-2" traffic barriers. On the bascule span, the roadway would be widened to 25', and vehicular and pedestrian traffic would be separated by including a 1'-2" traffic barrier. To accommodate the widened roadway and traffic barriers, the sidewalks would narrow to 3' wide on the bascule span. See Figure 3.

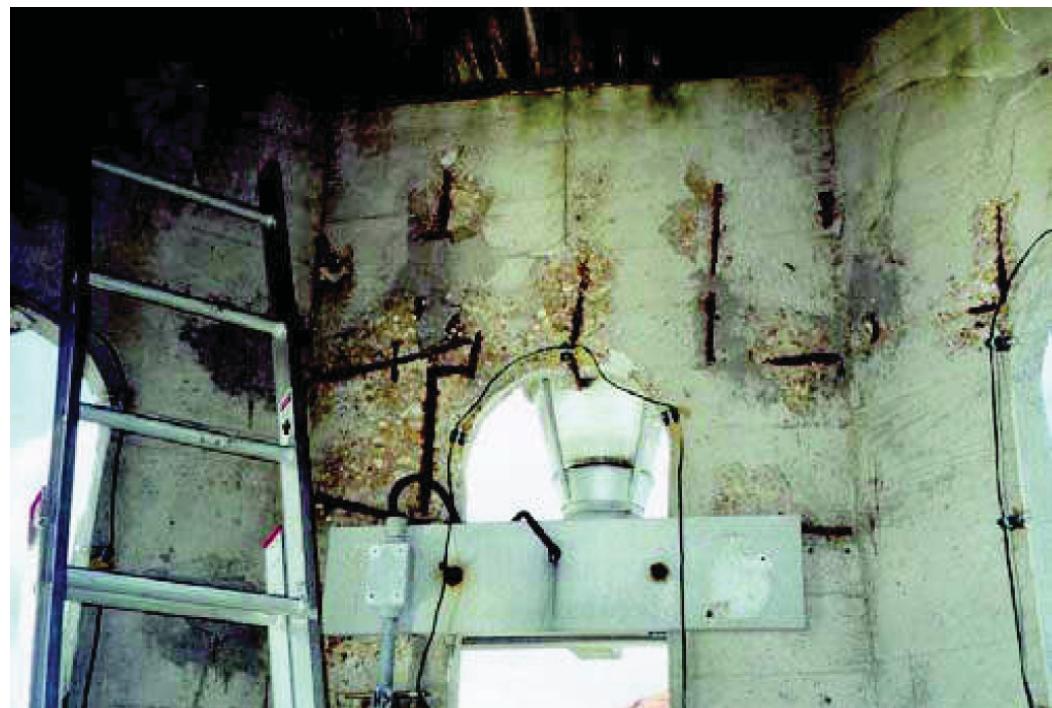
The towers require varying degrees of concrete repairs. Hollow areas, spalls, pop outs, cracks, and exposed reinforcing are present. The roofs have not been well maintained, so there is considerable damage to the cornices. See Figure 5.

Figure 5: Typical condition of interior of towers where windows have been left uncovered.

possible to conform to the standards and treatments. Our in depth inspection and testing program, discussed below, showed generally isolated areas of deterioration, at the NW and SW towers. More extensive deterioration is evident at the NE and SE towers.

The upper levels openings of the observation towers have been open to the weather and birds. Weather-proof windows are being installed. First level (at the roadway) fenestration is being replaced in accordance with the original plans. The towers are to be reroofed, using materials which are similar to the original construction, including the framing and finish materials. The roof tiles will be placed in accordance with the original plans.

The towers are prominent features of the bridge that are visually accessible from near and far. The deteriorated areas, identified and measured as part of the condition report for the bascule span, are to be repaired in accordance with generally accepted National Park Service conservation standards for concrete buildings. This includes carefully removing deteriorated areas to sound concrete, treating rusted steel, and placing new concrete to match the existing. All work will be blended with surrounding sound concrete. Specifications include the requirement for this work to be performed by skilled masons with demonstrated experience in concrete restoration. Approval of a test patch for the concrete finish coating is part of the project specifications.

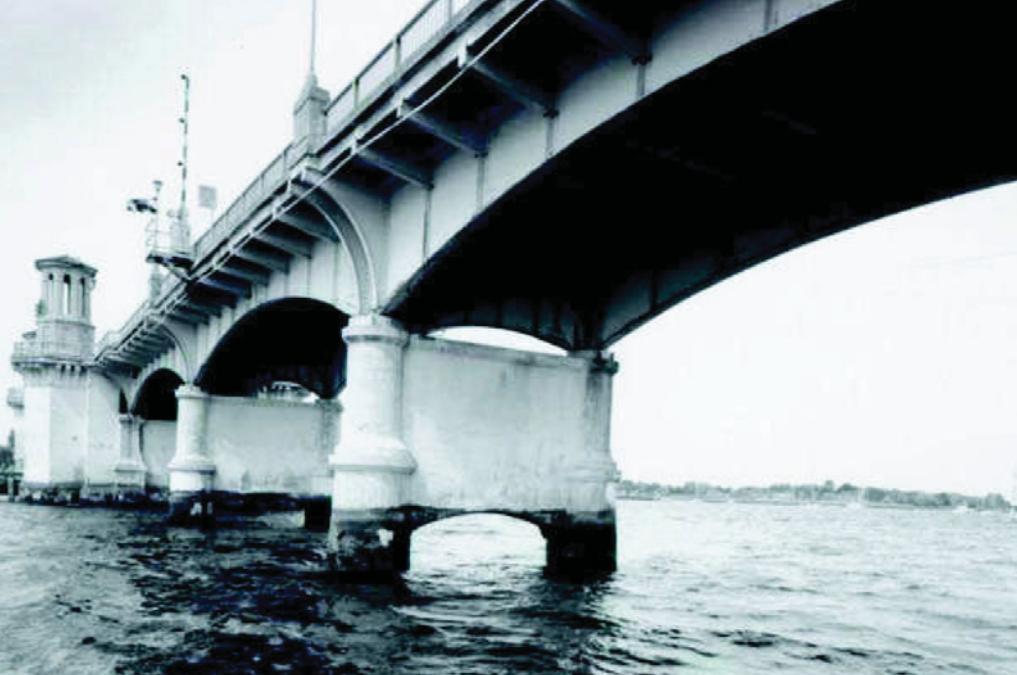
The in-depth inspection and testing program revealed that the approach span substructures were severely deteriorated and highly contaminated with chlorides. There has also been undermining and severe scour damage. As the bridge is being widened, the elephantine columns and partial web wall bents will be replicated and redesigned to accommodate the widening. The design of the existing open substructure, which is important to achieving the graceful arched rhythm of the bridge, lends itself well to the widening by repeating the column detail and making the plain web

Figure 7: Existing approach span underside and piers.

walls wider. See Figure 7. The in-kind replacement is in accordance with various Secretary of the Interior's standards and treatments and will compliment the reuse of the existing girders.

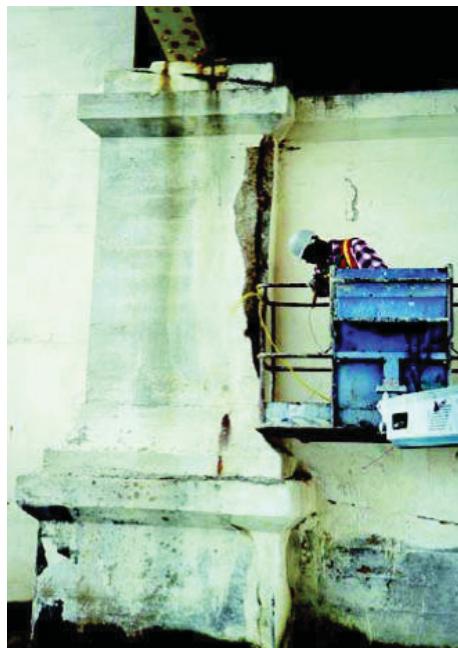
The piers typically had large spalled and hollow areas, zones of map cracking, and large open cracks due to corrosion of embedded steel. See Figure 9.

Figure 9: Typical condition of bascule piers.

Spalls typically had exposed and corroded reinforcing steel. Tests performed on the concrete core samples were compressive strength testing,

The results of the petrographic analysis indicate that the bascule pier concrete is poor to fair in quality, exhibiting non-uniform and high water/cement ratios, up to 0.65. Some air voids in the samples contained ettringite crystals, which are detrimental to the concrete due to its expansiveness over time, which may cause spalling and cracking.

chloride ion analysis (above) indicate that the concrete at both bascule piers is saturated with chloride ions which will facilitate corrosion of the reinforcing steel.

water, are detrimental to the concrete due to its expansiveness over time. Within 8' of the waterline, the chloride contaminated concrete is being removed to a depth of 6 inches. Additional thickness is being installed to allow for increased cover and the installation of an impressed current cathodic protection system. The band of extra thickness is continued around the entire pier with careful detailing at the plinth in the middle of the pier. Additionally, the openings in the counterweight pit are being sealed, and the exposed pier surfaces are being coated. These treatments should keep water from reacting with the ettringite crystals.

- ▶ Spall repairs - removal of contaminated and deteriorated concrete and cover restoration below Elev. +10.0, with individual repairs above that elevation;
- ▶ Close counterweight pits;
- ▶ New electrical room floors;
- ▶ Machinery platform at rear of each bascule pier to accommodate new drive machinery;
- ▶ Rear face column modifications; and
- ▶ Installation of 5 new drilled shafts at each pier with a new waterline footing built below the existing footing. This strengthening addresses the near loss of the existing foundations during the 100 year scour event and strengthens the foundations for vessel impact. Even though strengthening for scour is substantially more expensive, the strengthening costs are less than the costs for new bascule piers.
