REHABILITATION OF THE HISTORIC BRIDGE OF LIONS

BY ALAN KLEVENS, P.E.

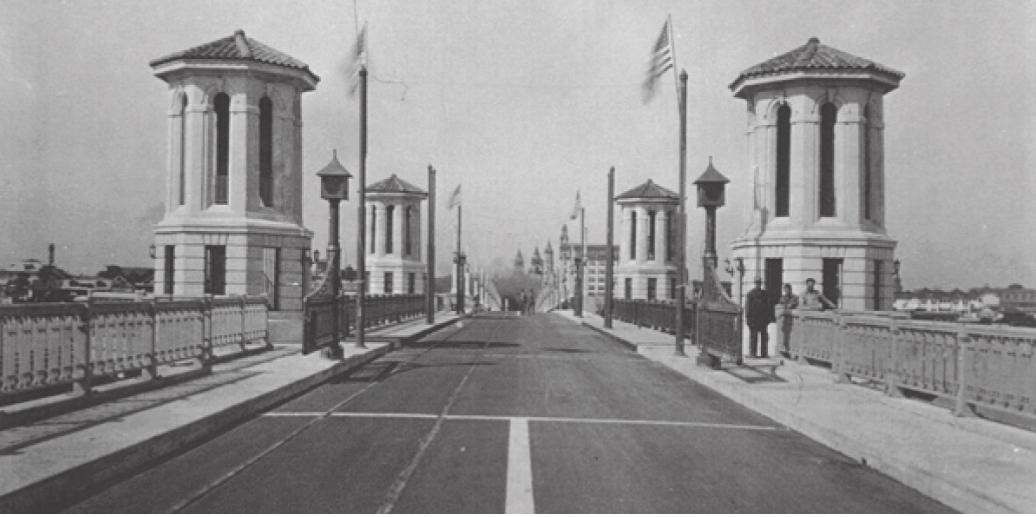
Figure 4: 1927 photograph showing ornamental traffic gates, railing, and observation towers.

gates for the bascule span, and given the high level of pedestrian use of the bridge, their reproduction and reinstallation as pedestrian barriers would enhance the historic character and experience of the bridge. See Figure 4 for original construction.

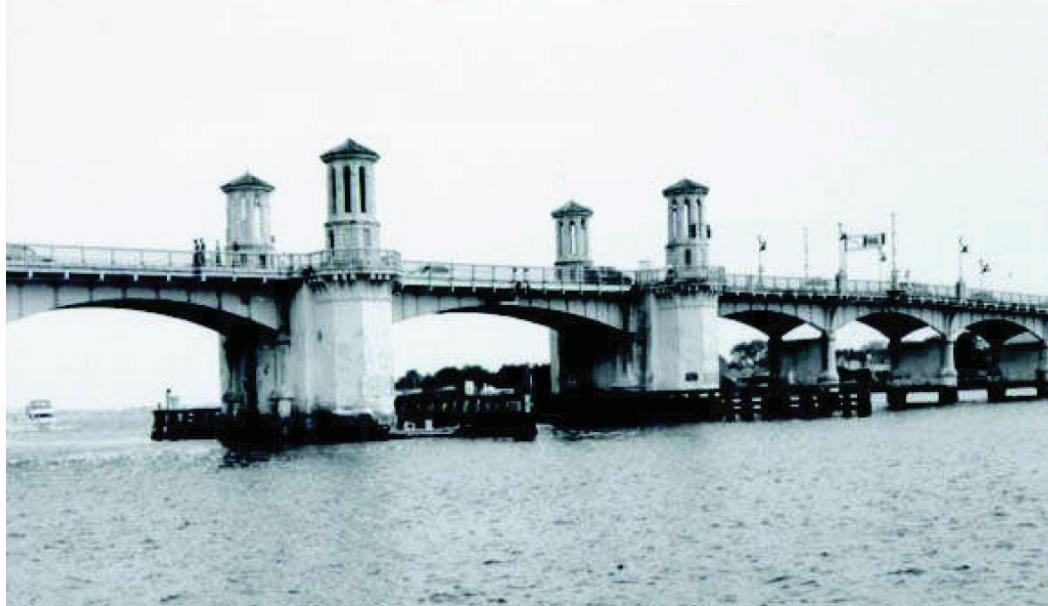
Figure 6: Elevation of existing bridge. Note arched girders and open approach pier configuration.

provide the characterdefining visual rhythm that the bridge achieves. See Figure 6. The retention of the approach span arched girders contributes greatly to the overall effectiveness of the rehabilitation of the bridge. Since a project requirement is to provide a wider roadway over the bridge, the girders are being moved outward rather than adding a wider cantilevered deck section on new, larger brackets.

Because of the overall importance of the arched girders, they are being rehabilitated and reused. The girders will be removed from the site, deteriorated material replaced in kind using button head bolts, the steel painted in the shop, and then returned to the site and installed on new piers. The bridge is large enough that moving each girder outward approximately 3 feet to accommodate the bridge widening, will not adversely affect the historic appearance if the substructure is replaced in kind. In elevation, the bridge will be unchanged. The bridge will appear as it presently does from the shorelines.

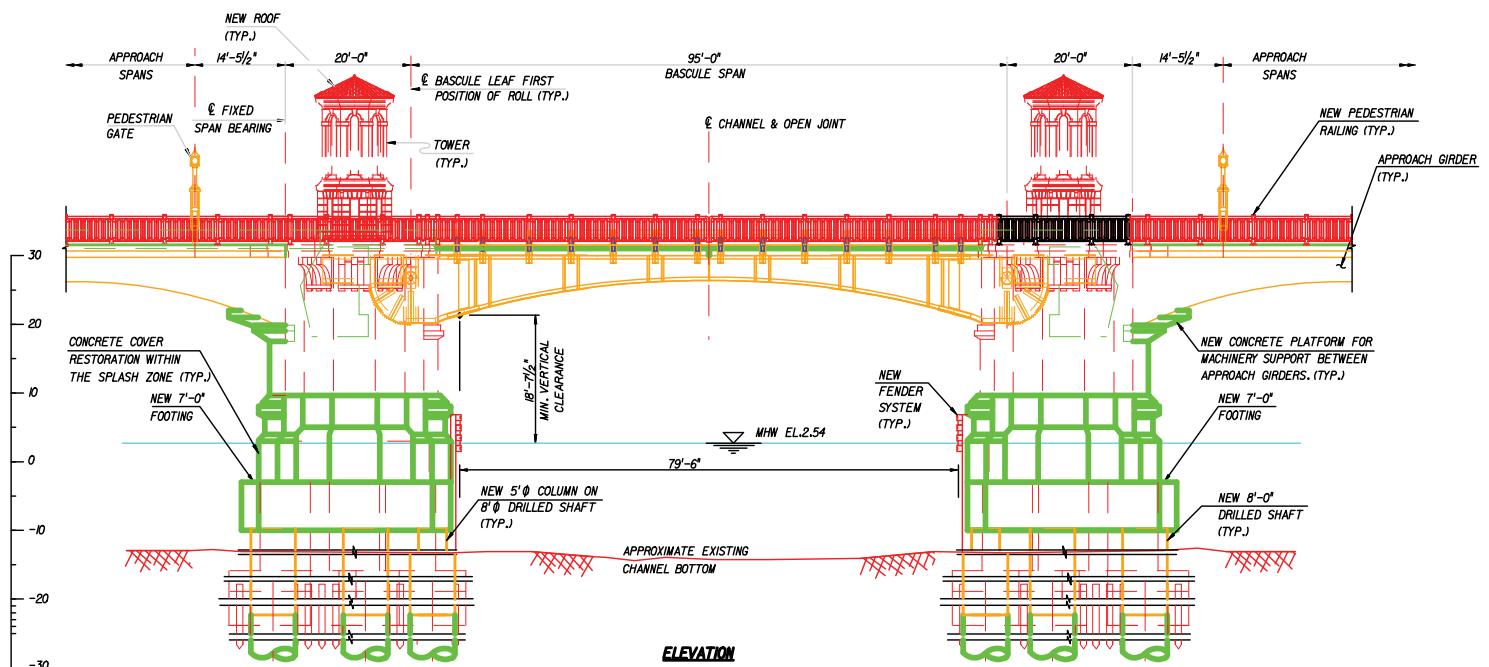
Figure 8: Elevation of rehabilitated bascule span and piers. Note new machinery platforms.

that neither the shape nor details of the piers be changed. The concrete cantilever brackets at the upper levels of the piers will be preserved to maintain the look and feel of the bridge. Changes at the top of pier where the bascule girders on the channel side, and the flanking span girders in the back, extend through are acceptable, since they are mostly hidden from view. The changes required include moving the supports for the flanking span outward to accommodate the widening, and installation of a new cantilevered concrete platform to accommodate the new span drive machinery. See Figure 8.

Repair of concrete on the bascule piers will be done to the same matching procedures as the towers. Our inspection and testing program revealed large spalls, hollow areas, inadequate cover, chloride contamination to a depth of 6", and ettringite crystals, which in the presence of

water, are detrimental to the concrete due to its expansiveness over time. Within 8' of the waterline, the chloride contaminated concrete is being removed to a depth of 6 inches. Additional thickness is being installed to allow for increased cover and the installation of an impressed current cathodic protection system. The band of extra thickness is continued around the entire pier with careful detailing at the plinth in the middle of the pier. Additionally, the openings in the counterweight pit are being sealed, and the exposed pier surfaces are being coated. These treatments should keep water from reacting with the ettringite crystals.
